LAKE OF THE HILLS DAM
BOLLINGER COUNTY, MISSOURI
MISSOURI INVENTORY NO. 30077

PHASE I INSPECTION REPORT
NATIONAL DAM SAFETY PROGRAM

PREPARED BY: ST. LOUIS DISTRICT CORPS OF ENGINEERS
FOR: GOVERNOR OF MISSOURI

AUGUST 1979

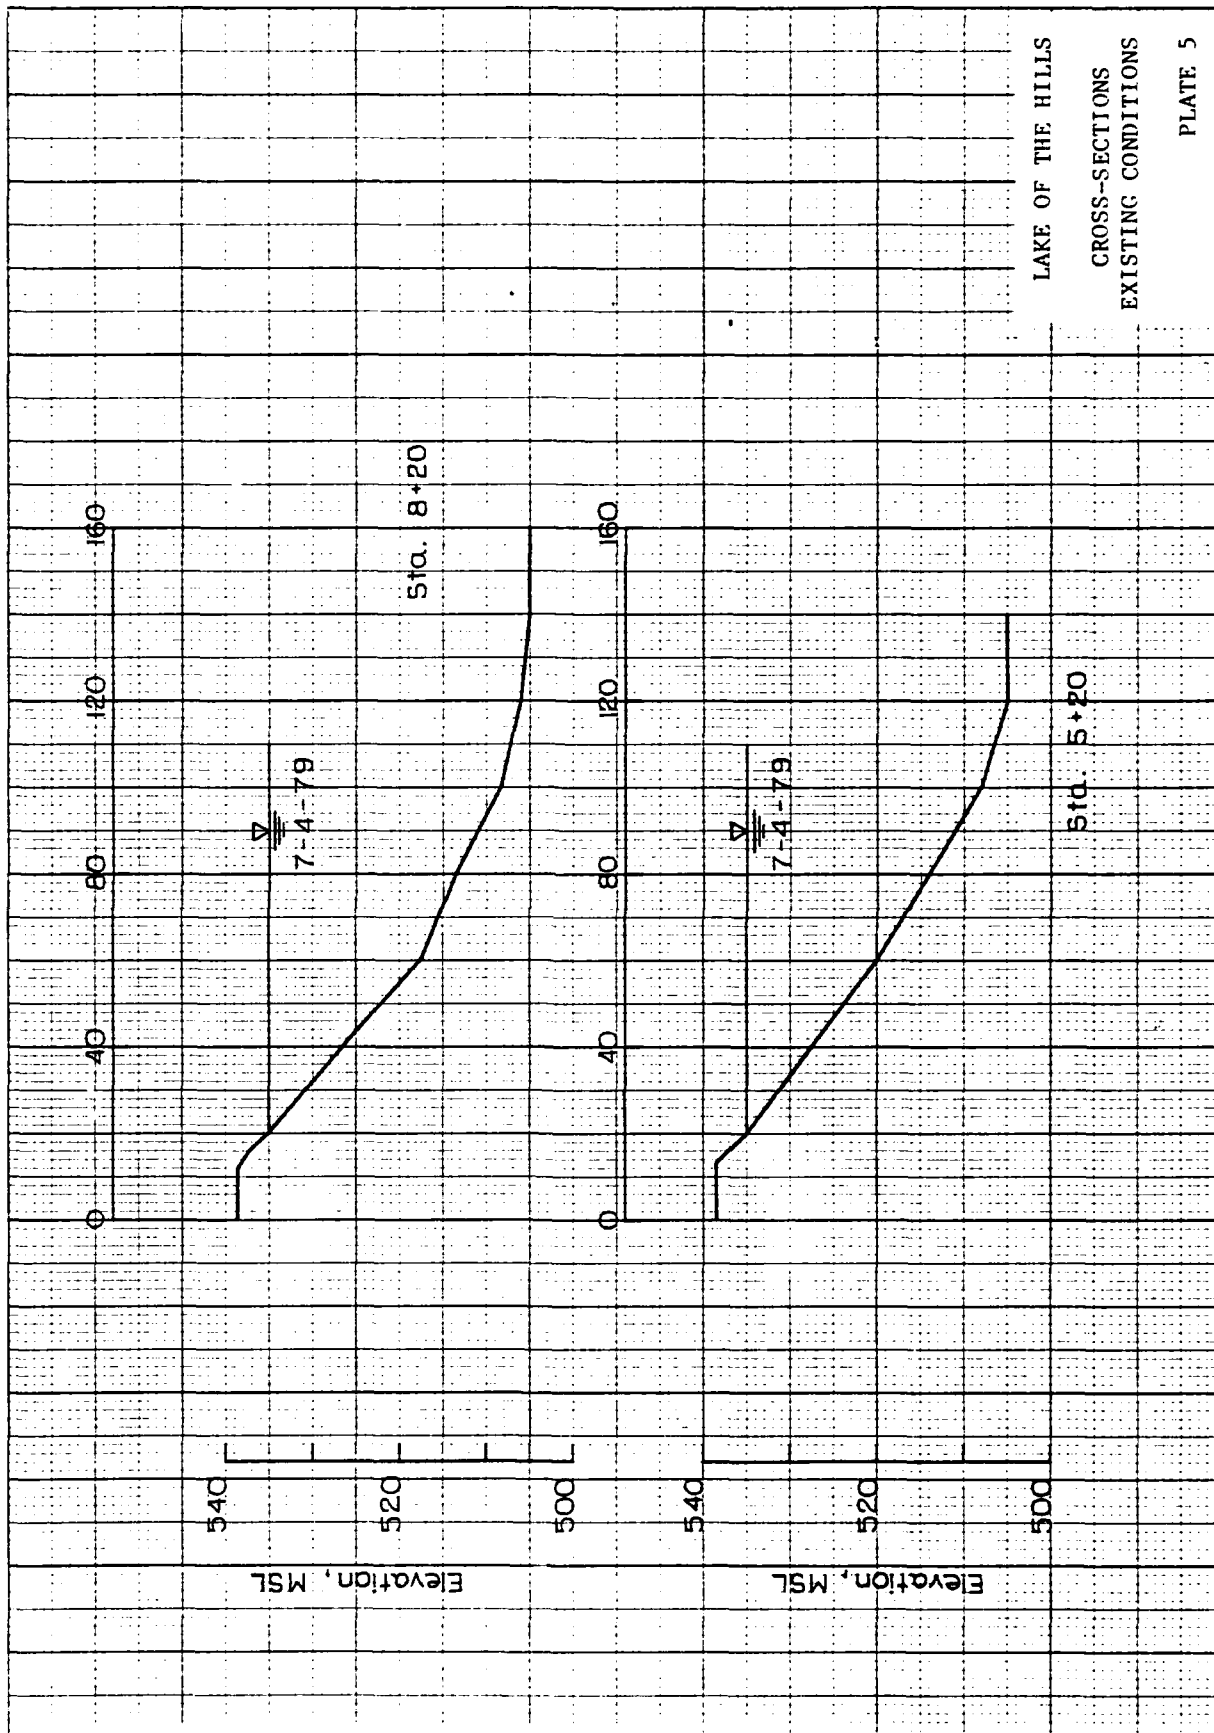
LAKE OF THE HILLS
CROSS-SECTIONS
EXISTING CONDITIONS
PLATE 5

c. Dam. No detrimental settlement, cracking, or animal burrows were observed in or near the earth embankment. Typical existing cross-sections of the embankment are shown on Plates 4 and 5. These sections are fairly consistent with the reportedly constructed slopes of 1V on 3H (upstream) and 1V on 2H (downstream) except the existing downstream slope appears somewhat flatter (approximately 1V on 2.25H). The crown width of the dam is 20 feet.

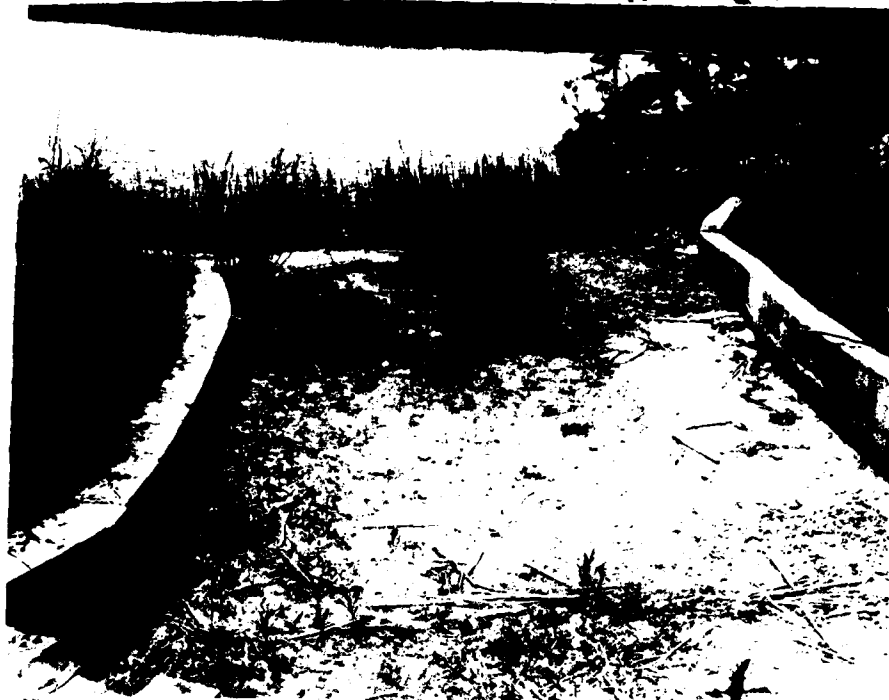
An emergency spillway located in the left abutment consists of a 125-foot long rectangular concrete channel with an average bottom width of 14 feet (see Photos 13 and 14). The concrete in the spillway appears to be in good condition. The downstream end of the emergency spillway, however, is in the process of being undermined (see Photo 15).
